This spreadsheet performs screening level calculations to estimate the effect of peeling leaded paint on the average concentration of lead in yard soil
3548 Gilpin Street

LBP Assessment Results

Property ID # 2670 / 3548 Gilpin Street

SITE NAME: VASQUEZ BOULEVARD AND I-70

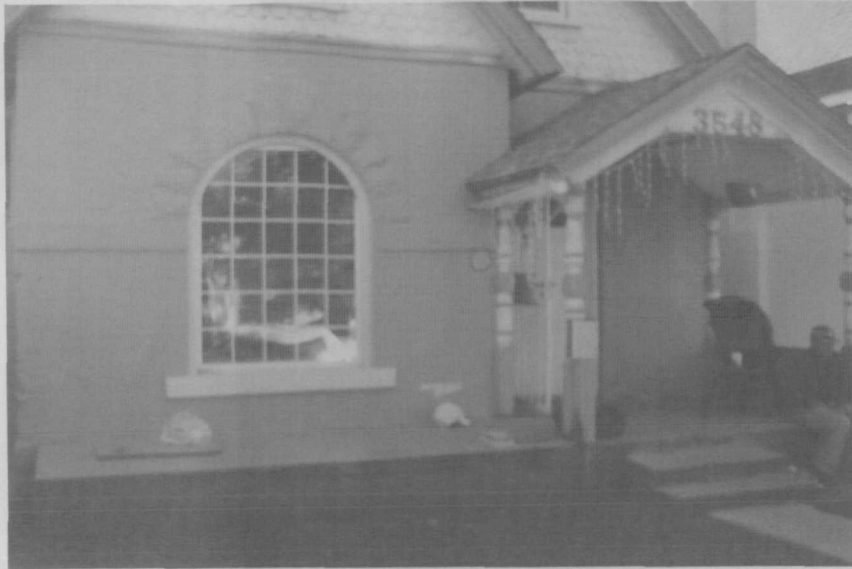
West porch exposure of property

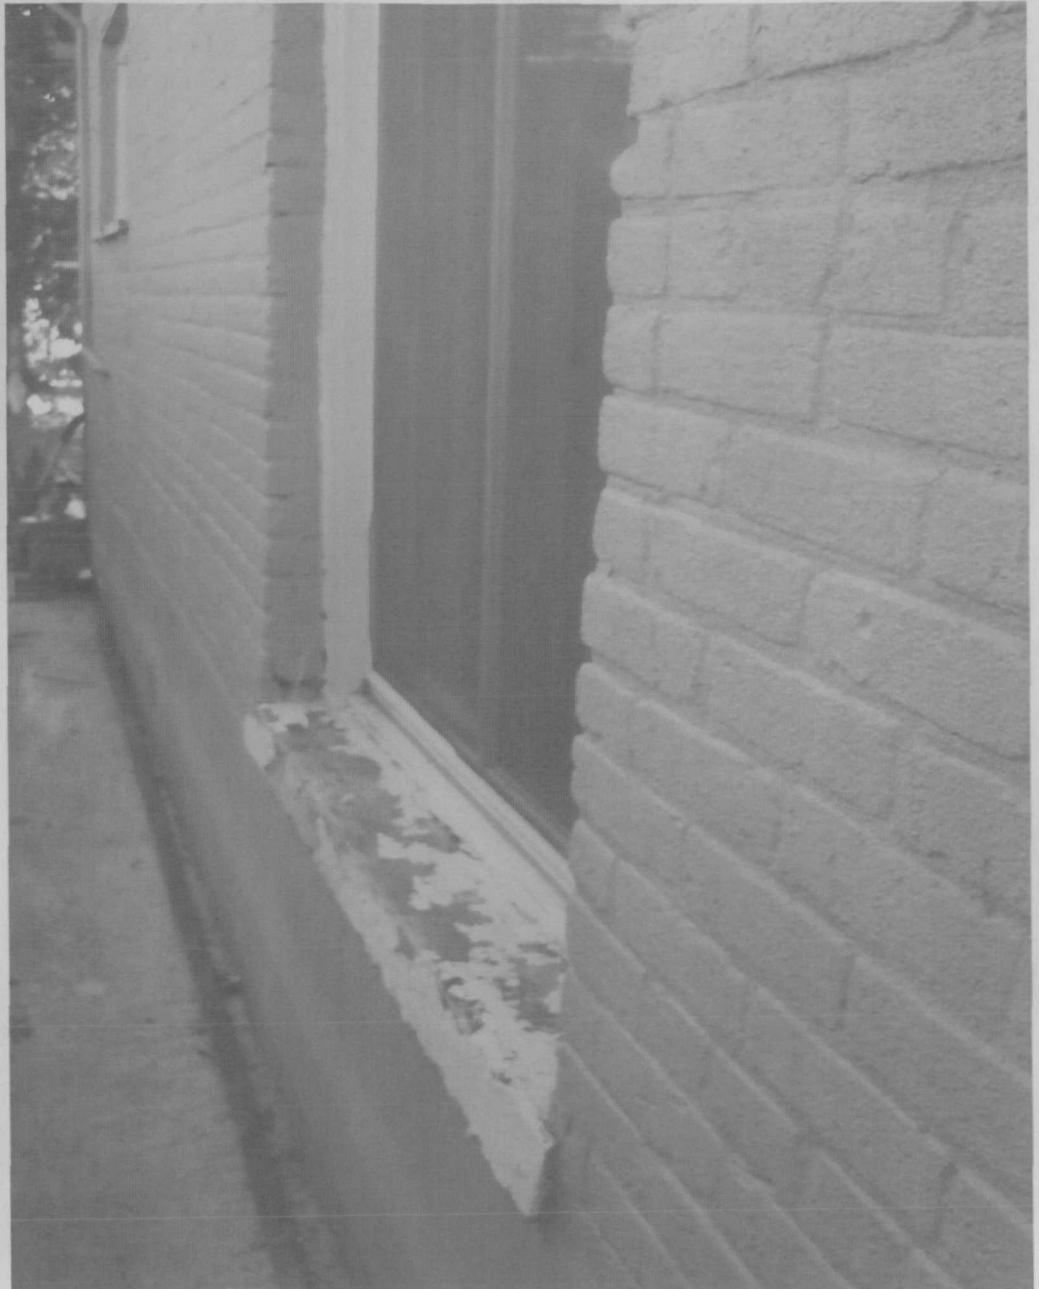
North exposure wood window sill contains peeling lead paint

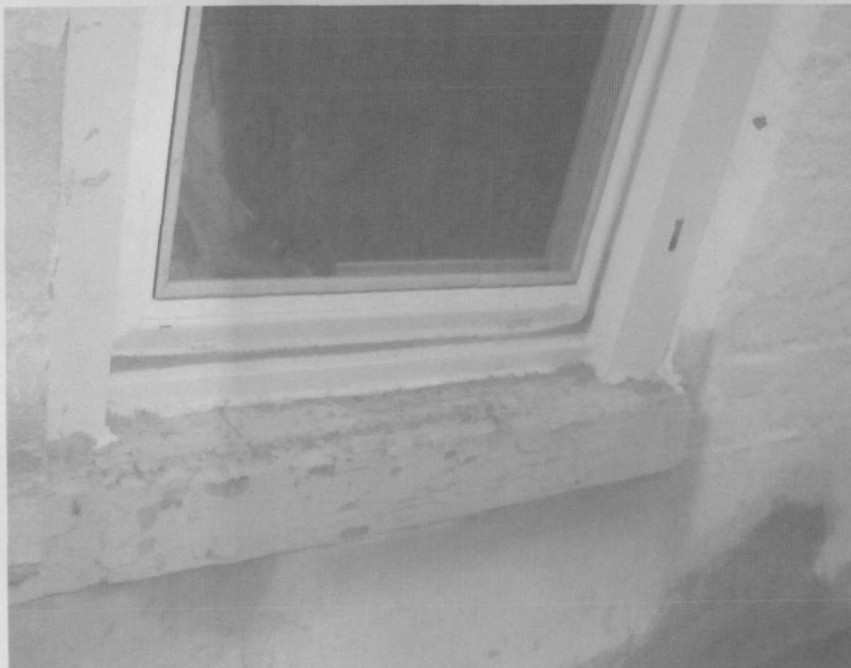
South exposure wood window sill contains peeling lead paint

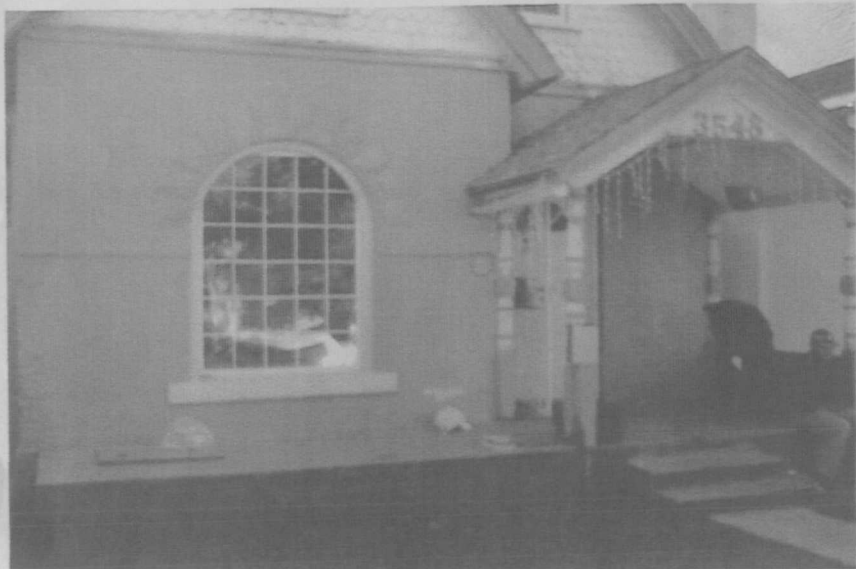
West porch exposure of property

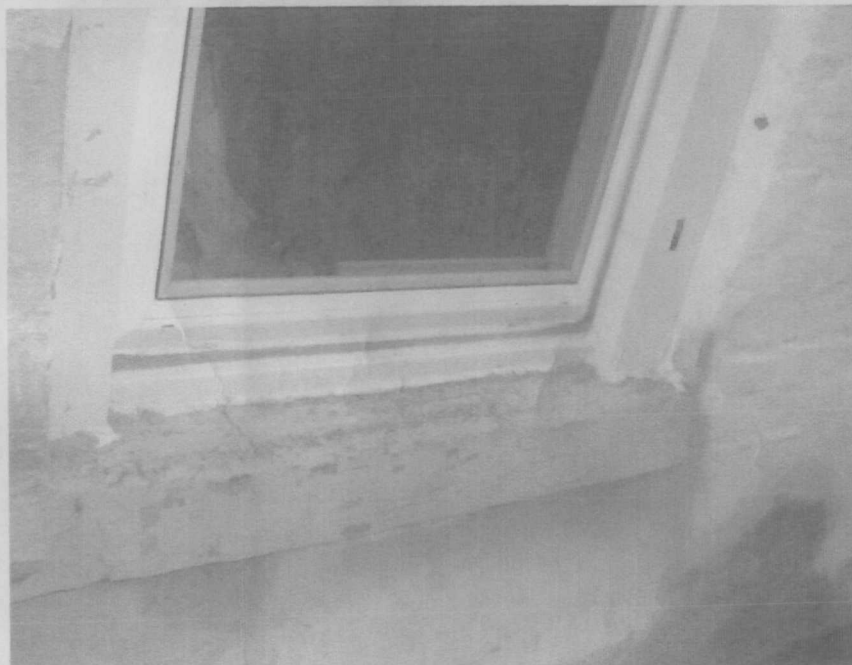
South exposure wood window sill contains peeling lead paint

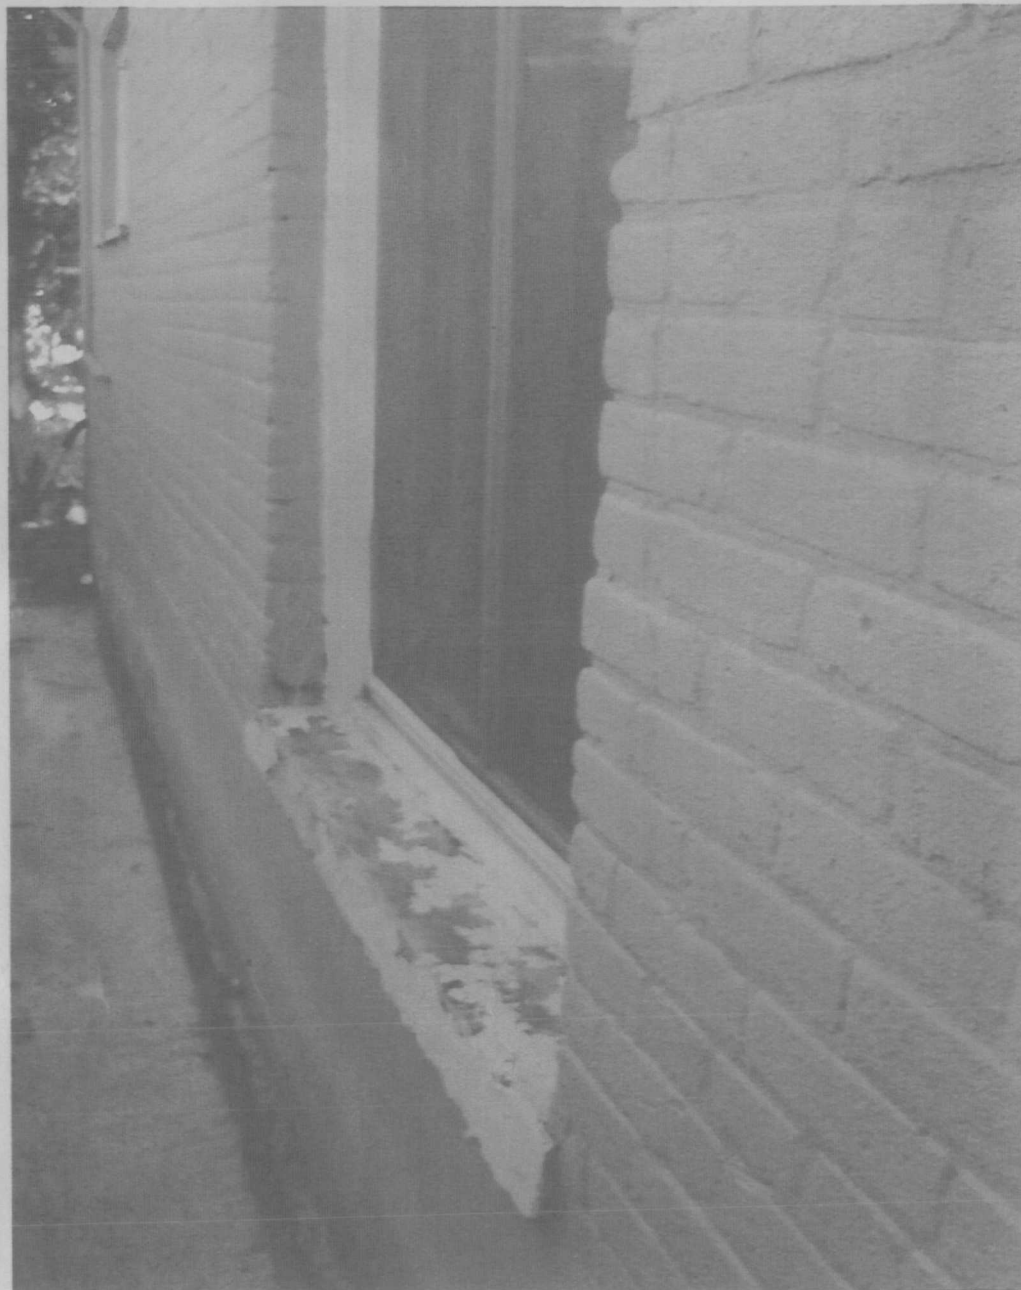
North exposure wood window sill contains peeling lead paint
